A. Case study 1: A Detailed Design Stage Audit of the Proposed Duplication of a National Highway

Table 8: Case Study 1–Findings of a Detailed Design Stage Audit of the Proposed Duplication of a National Highway

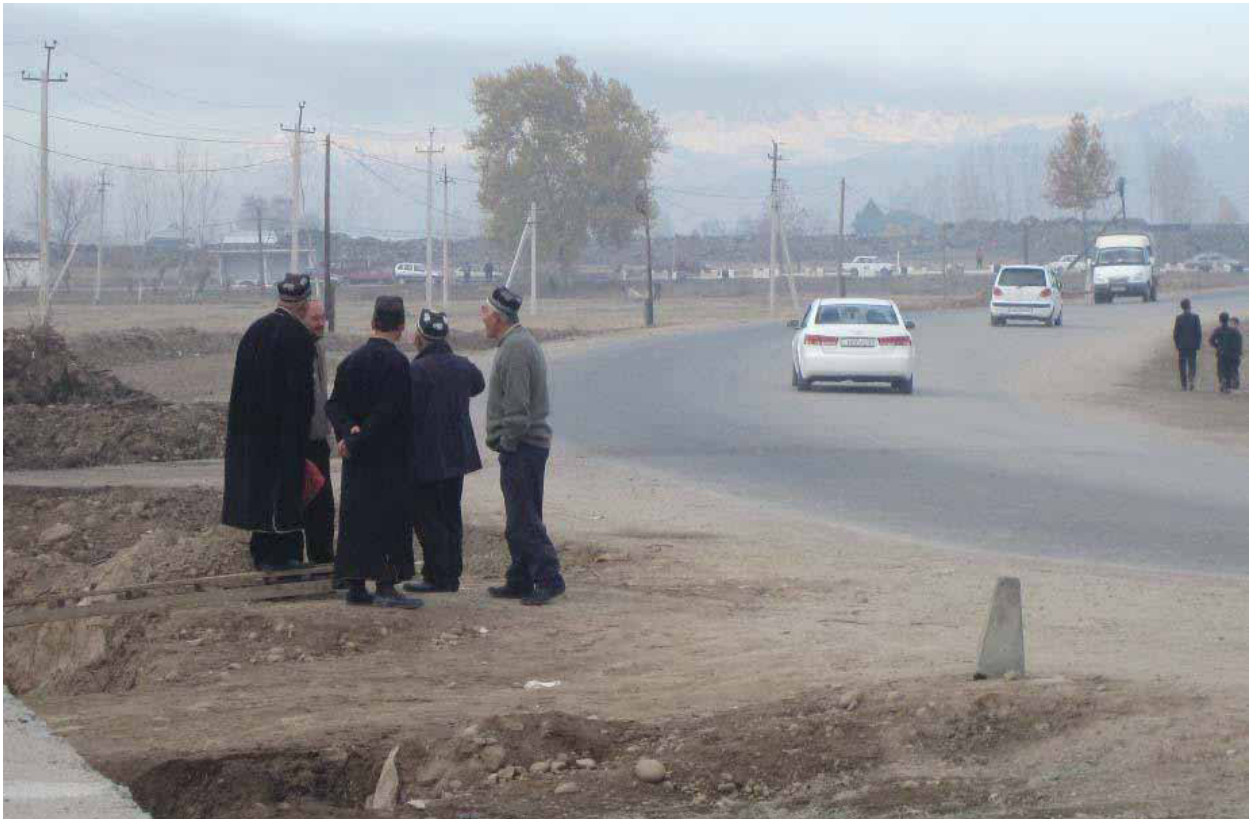
The existing single carriageway highway near Km 21 shows typical road user groups.

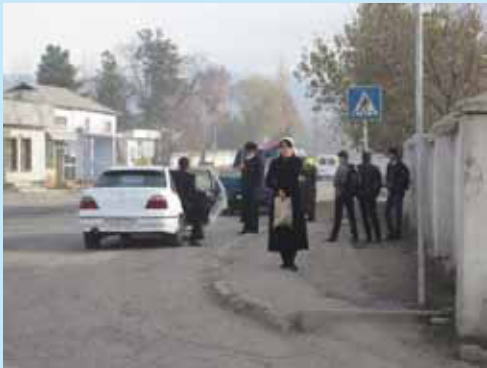
Km	Safety Concern	Risk	Photo	Recommendations	Client Response
Safety Concerns with the Proposed Duplication of the National Highway					
From Km 5+400 to Km 6+300	This section of road passes through a village, and it will be subjected to high-speed traffic once the road is built. There will be a risk of high-speed collisions between through traffic and pedestrians in this village. It warrants speed management to maintain speeds at or below 40 km/h because of the high numbers of pedestrians in this village. The drawings do not show any “traffic calming” treatments proposed.	Very high

<ul style="list-style-type: none"> • Install a “gateway” on both approaches to this village. • Install flat-topped road humps at spacings of approximately 150 m through the village. Ensure humps are located close to bus stops and the police station, that they are well-signed, marked, and lit. • Provide a physical median through the village (to serve as a refuge), but DO NOT install barrier or fencing on the median.

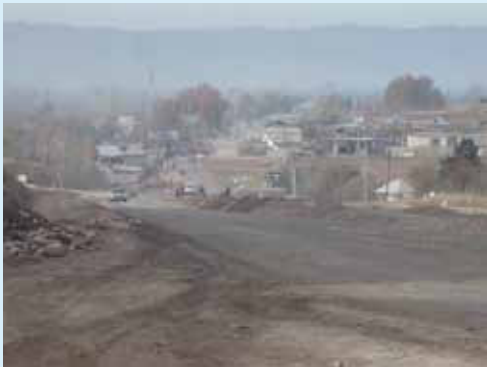
From Km 13+500 to Km 14+300	This village is located at the end of a long, straight, downhill section of road (from the capital) and a long, straight, flat section of road (from the southwest). Speeds will be high through this village once the highway is duplicated. The highway takes a right-hand curve in this village, and a major side road continues straight. The village warrants speed management to maintain speeds at or below 60 km/h because of the many pedestrians in this village. The drawings are silent about this.	Very high

<ul style="list-style-type: none"> • Install a “gateway” on the three approaches to this village. • Install flat-topped road humps at spacings of approximately 150 m through the village. Ensure humps are located close to bus stops, mosques, and schools; and that they are well signed, marked, and lit. • Provide a raised concrete median 2 m wide through the village to serve as a pedestrian refuge. • DO NOT install barrier or fencing on the median.

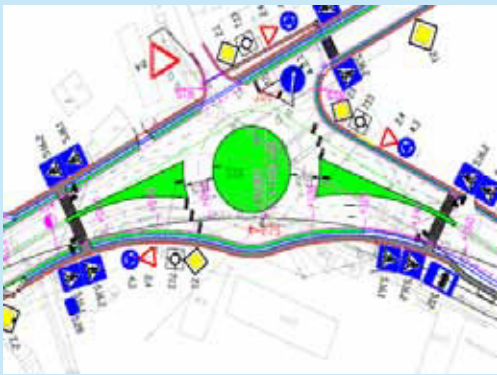
Km	Safety Concern	Risk	Photo	Recommendations	Client Response
Km 14+080	The design for the roundabout proposed for this key intersection in this village has insufficient deflection from the west and from the south to cause drivers to slow sufficiently. This lack of adequate deflection will increase crash risk at the roundabout.	Medium

<p>Source: China Road and Bridge Corp.</p>	<ul style="list-style-type: none"> Review this design, and attempt to improve deflection for these approaches. If this is not possible, reconsider the use of a roundabout at this intersection. Seek alternative traffic control options instead. 	
Km 15+710	At Km 15+710, a median opening and a T junction are proposed for access to the Village Access Road. The median opening will also serve as a U-turn opportunity. However, there are no sheltered left turn lanes proposed in the median for either direction. There will be a high risk of rear-end collisions at this location as vehicles slow down to turn from the “fast” lane.	Medium
