B. Case study 2: A Detailed Design Stage Audit of the Reconstruction of a 300-km Section of a National Highway

Table 9: Case Study 2–Findings of a Detailed Design Stage Audit of the Reconstruction of a 300-km Section of a National Highway

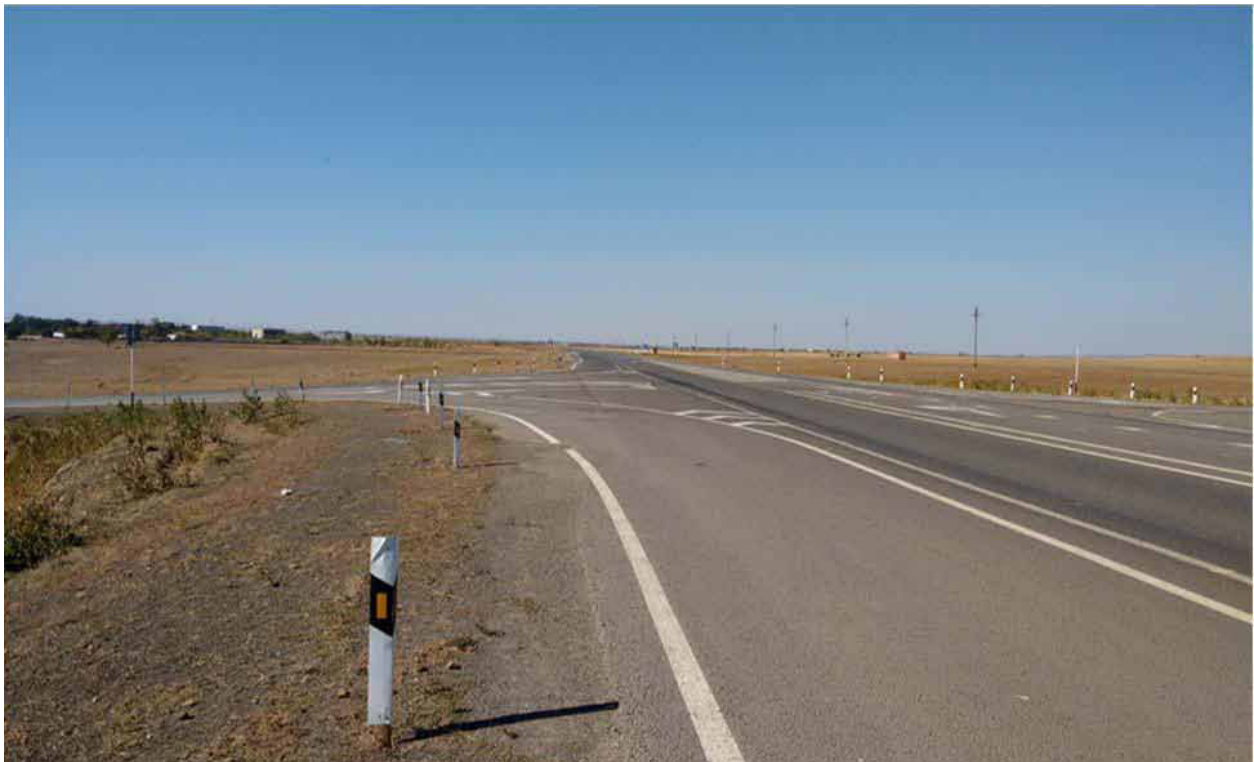
An intersection on a recently rehabilitated section of A-27, 25 km north of the start of the proposed works.

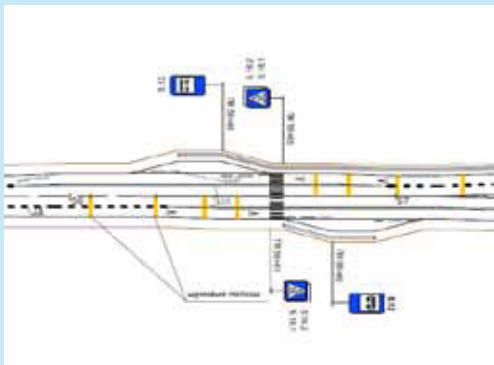
Km	Safety Concern	Risk	Photo	Recommendations	Client Response
Safety Concerns with the Proposed Reconstruction of the National Highway					
General	<p>Throughout the scheme, pedestrian crossings have been proposed to link communities with bus stops. In most locations, these crossings straddle four lanes with no refuge for crossing pedestrians. Users of the crossings will effectively have to cross with no control in a single phase. The presence of the second lane will encourage overtaking in the vicinity of the crossings and potentially higher speeds. These combined factors will increase the risk of conflict between pedestrians and vehicles.</p>	Very high

<p>Source: TOP Geodezia, Almaty.</p>	<ul style="list-style-type: none"> • Reduce the carriageway from four to two lanes at these locations. • Provide appropriate lengthened entry and exit tapers to negate the need for extra lanes. • Any acceleration lanes for adjacent junctions should terminate in advance of the bus stops, not continue through the bus stop location.

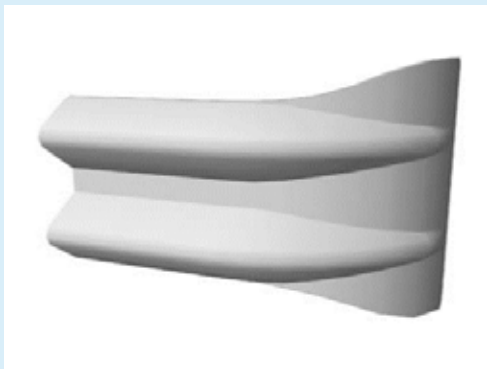
General	<p>The standard drawings show the crash barrier terminals to be provided throughout the scheme will be the “fish tail” type. These terminals, when facing oncoming traffic, are a considerable roadside hazard and a “spearing” hazard. They cause injury to vehicle occupants should an errant vehicle strike them.</p>	Medium

<p>Source: Matthew Chamberlain.</p>	<ul style="list-style-type: none"> • Provide passively safe terminal ends for all barrier terminals. • Ensure the standard drawings are altered so “fish tail” terminals are removed and an approved passively safe terminal shown instead.

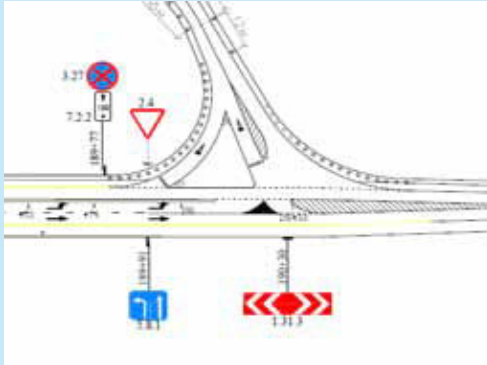
Km	Safety Concern	Risk	Photo	Recommendations	Client Response
Km 190	<p>A side road joins the main line here at an acute angle and the exit and entry radii are very relaxed, increasing the entry speeds of vehicles entering from the side road. This also will encourage high-speed movements onto the side road. This problem is exacerbated by the size of the junction and the lack of any physical islands within the junction; only road markings are proposed. This will increase the risk of “give way” conflicts. It will also increase the risk of vehicles entering the side road at high speed and losing control.</p>	High

<p>Source: TOP Geodezia, Almaty.</p>	<ul style="list-style-type: none"> • Provide tighter radii to cause drivers to reduce speed on their approach to the main line, and also while entering from the main line onto the side road. • Reduce the size of the junction to encourage lower vehicle speeds. • Provide a physical (not painted) island within the junction to deter vehicle from crossing into opposing lanes.

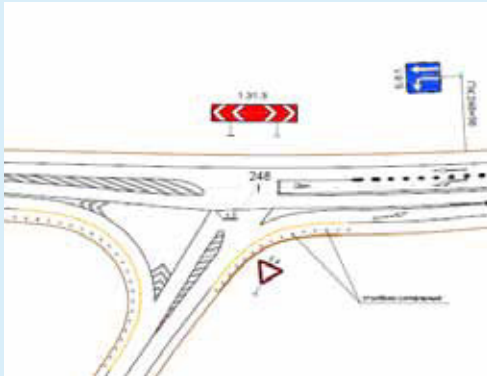
Km 248	<p>A side road joins the main line at an acute angle here. The exit and entry radii are very relaxed, which will increase the entry speeds from the side road. They will also encourage high-speed entry movements into the side road. This will increase the risk of “failure to give way” conflicts as well as vehicles potentially entering the side road at high speed and losing control.</p>	High

<p>Source: TOP Geodezia, Almaty.</p>	<ul style="list-style-type: none"> • Provide tighter radii to cause drivers to reduce speed on the approach to the main line, and also when entering from the main line onto the side road.

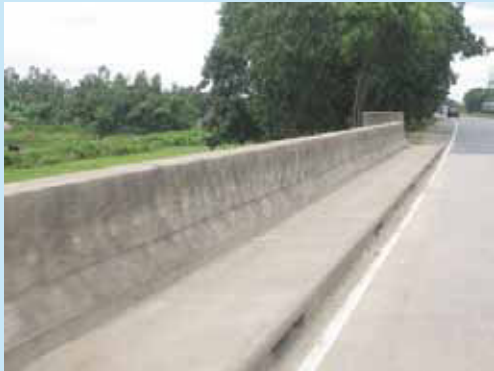
Km	Safety Concern	Risk	Photo	Recommendations	Client Response
Km 277	There is an existing narrow bridge across a wide river (500 m) here. It has large concrete parapets that are roadside hazards. It is the only such bridge along this highway and, as such, it may surprise some drivers. The drawings are silent about any safety improvements at or along this narrow bridge. W-beam safety barrier is needed to shield the side slopes, and there is a need to delineate the bridge to reduce the risk of side swipe collisions at night.	High

<ul style="list-style-type: none"> • Install a pair of “Narrow Bridge” warning signs approximately 100 m ahead of the bridge on each approach. • Install “width markers” on each parapet 2 m above the road surface to delineate the corners of the narrow bridge. • Install lengths of W-beam barrier to shield the side slopes on both sides of the highway. • Stiffen the barrier over the last 10 m by reducing the post spacings to half. • Affix the barrier firmly to the parapets.

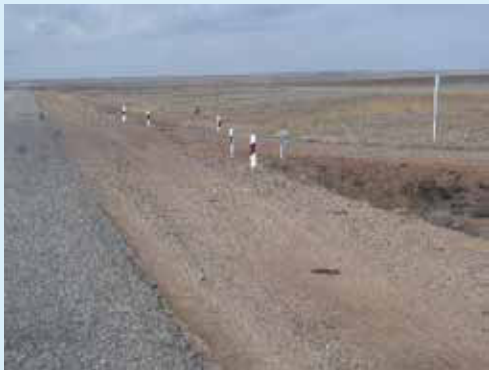
Km 297.7	Pedestrians walk along a small side road on the right) from a village to the highway to catch minibuses. They cross the highway to do this. However, the drawings do not show anything to assist them with their crossing of the highway. Traffic speeds at the location are high and may increase after the rehabilitation. A pedestrian crossing is not appropriate due to the low volumes of pedestrians and the high speed of traffic. A refuge island offers the safest option for all.	Medium

<ul style="list-style-type: none"> • Ensure the safety of these pedestrians is discussed and resolved before the designs are completed. • Consider installing a length of divided road (up to 200 m long) with a median at least 3 m wide to provide a refuge for crossing pedestrians. • Install appropriate warning signs on both approaches—for the median and the pedestrians. • Consider a shelter for pedestrians.
