C. Case study 3: Roadworks Stage Audit of the Upgrading of Two Sections of an International Highway

Table 10: Case Study 3–Findings in a Roadworks Stage Audit of the Upgrading of Two Sections of an International Highway

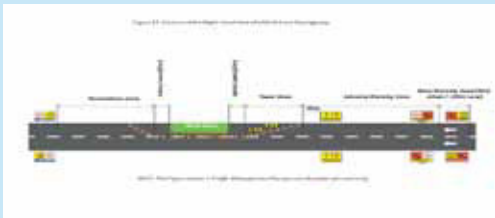
Km	Safety Concern	Risk	Photo	Recommendations	Client Response
Safety Concerns Identified in the Desktop Audit of the Traffic Management Plans for the International Highway					
General	There are inadequate numbers of reflective warning signs shown in the TMP. The existing highway has speeds of up to 80 km/h in parts, and it is possible some drivers could miss seeing an advance warning sign on the left side of the highway. All warning signs should be duplicated (on both sides of the road) in the advance warning zone.	High

<p>Source: CAREC Manual 2.</p>	<ul style="list-style-type: none"> Duplicate all road work signs used in this project by ensuring that a matching sign is placed on the right side of the carriageway to match the sign(s) installed on the left side. 	
General	There are no speed restriction or repeater speed restriction signs shown in the TMP. Consistent application of a 40 km/h speed limit through each work zone is recommended for the safety of road users and road workers.	High

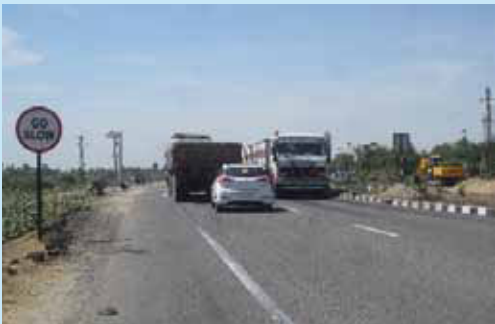
Km	Safety Concern	Risk	Photo	Recommendations	Client Response
From Km 252.1 to Km 256.7	No “Two Way Traffic” warning signs are shown in the TMP to warn and/or inform drivers in both directions when counterflow arrangements exist. One “Go Slow” sign is in place but it is general and gives no warning of the risk of head-on collisions. Allowing drivers to forget they are on a two-way road sets up a high risk of head-on collisions.	High

<ul style="list-style-type: none"> Redesign the TMP to show the installation of duplicated, reflective “Two Way Traffic” warning signs at spacings not exceeding 500 m through the counterflow section of the duplicated highway. Ensure the warning signs face both directions of traffic. 	
General	No workers were sighted wearing reflective or high visibility clothing on-site during the site inspections. This is a requirement in the contract and is essential for personal safety.	Medium

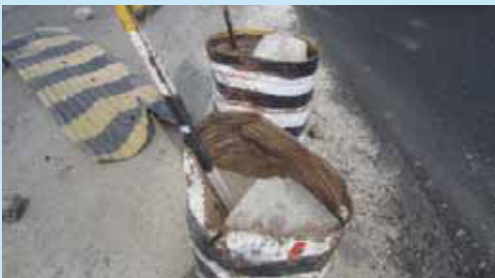
Km 256+200	Concrete-filled barrels are used as delineators and to hold some “Diversion” signs at this work site. These are roadside hazards and are highly dangerous if struck by a small vehicle or a motorcyclist.	Medium

<ul style="list-style-type: none"> Direct the contractor to remove these concrete-filled drums and replace them with conspicuous but forgiving traffic control devices (such as plastic traffic cones, bollards) and reflective metal signs.
