D. Case study 4: A Preopening Stage Audit of a 120-km Section of a National Highway in the Western Province

Table 11: Case Study 4–A Preopening Stage Audit of a 120-km Section of a National Highway in the Western Province

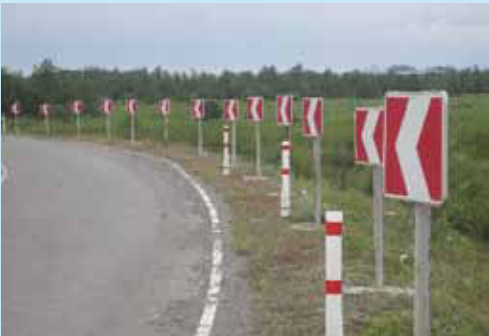
Km	Safety Concern	Risk	Photo	Recommendations	Client Response
Safety Concerns along the Newly Completed National Highway in the Western Province					
General	Curves are delineated inconsistently. Several have too many CAMs installed, some have CAMs in one direction only (the other direction is not delineated), and there are several curves (especially in the hill section) that need CAMs but have none. Such inconsistent delineation can cause drivers to be surprised at sharp curves; run-off-road crashes can result.	High

<ul style="list-style-type: none"> • Undertake a review of the delineation (especially the use of CAMs) throughout the length of the highway. • Ensure all curves with a radius less than 150 m have at least three CAMs (with standard spacings) installed on the outside of the curve to face both directions of travel. • Remove redundant CAMs. 	
General	<p>The line marking is clear and correct at the beginning of the newly completed road. However, the edge lines are not continuous in the second half of the highway. Loose gravel and sand from the shoulder are obscuring most of the edge lines installed.</p> <p>This leads to safety issues due to reduced daytime and nighttime delineation.</p>	Medium

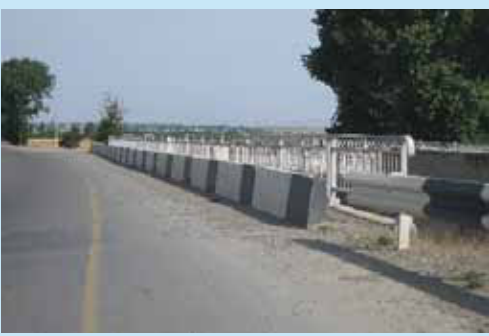
General	W-beam barrier is installed at each of the six bridges along this highway to shield the side slope on each approach. However, none of these sections of barrier were stiffened nor correctly affixed to the bridge parapets. There is a risk of “pocketing” into these bridge parapets.	Medium

<ul style="list-style-type: none"> • Ensure the barrier is securely attached to the bridge parapets as described in the <i>CAREC Roadside Hazard Management Manual</i>. • Reduce the post spacings in the final 10 m before each bridge to half of the original spacing. Use double-nested railing as necessary to prevent “pocketing”.

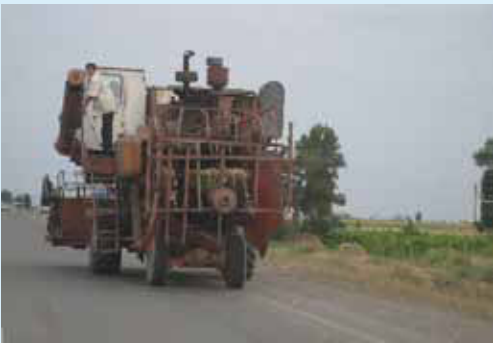
Km	Safety Concern	Risk	Photo	Recommendations	Client Response
Km 10–14	At the large cross-intersection at Km 10.8, many items of agricultural machinery enter and leave the highway. They travel slowly along the highway for about 3 km to either the local petrol station or the next side road junction near Km 13.6. However, the shoulders are unsealed, and the drivers try to stay on the highway to minimize dust. Because they are slow-moving and large machines, they are difficult to overtake. Head-on and rear-end collisions may result.	Low

<ul style="list-style-type: none"> • Pave the shoulders of the highway between Km 10+00 and Km 14+00 to a width at least 2 m to provide an option for drivers of large machinery to use. • Install advance warning signs on the highway to advise drivers of the possibility of machinery using the road. • Install two street lights at the crossroad at Km 11.8 and another two at the side road junction near Km 13+60 to highlight turning vehicles.

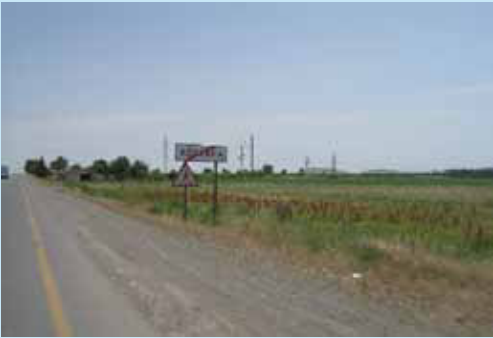
Km 45	There is a school on the right (north) side of the highway near Km 45. It is approximately 600 m outside the nearby village, and it appears most of the young children attending the school walk along the edge of the highway from the village. With an unpaved shoulder and nearby long grass, children sometimes walk on the road pavement. This exposes them to a risk of a collision with fast-moving traffic.	Medium

<ul style="list-style-type: none"> • Discuss options with the school. • Pave the shoulders between the village and the school (at least 2 m wide). • Construct an all-weather footpath (and possibly cycling path) within the road reservation (right side). This off-road path should be at least 3 m wide and should have a sign indicating it is for pedestrians and cyclists only. 	
Km 60–64	There are steep, undriveable roadsides in the hill section between Km 60 and Km 64 (approximately). Some W-beam barriers are installed, but are too short in four places, leaving unsafe side slopes unshielded. These side slopes are a serious risk to the occupants of errant vehicles. The slopes cannot be “softened” due to the topography. High-quality delineation and more safety barriers are needed.	High
