ROAD TRAFFIC ACCIDENT DATA COLLECTION AND ANALYSIS WORKSHOP COUNTRY: MONGOLIA

TA-6763 REG: Accelerating Innovation in Transport

CRASH DATA ANALYSIS

CASE STUDY 1: CAR COLLISION WITH TREE

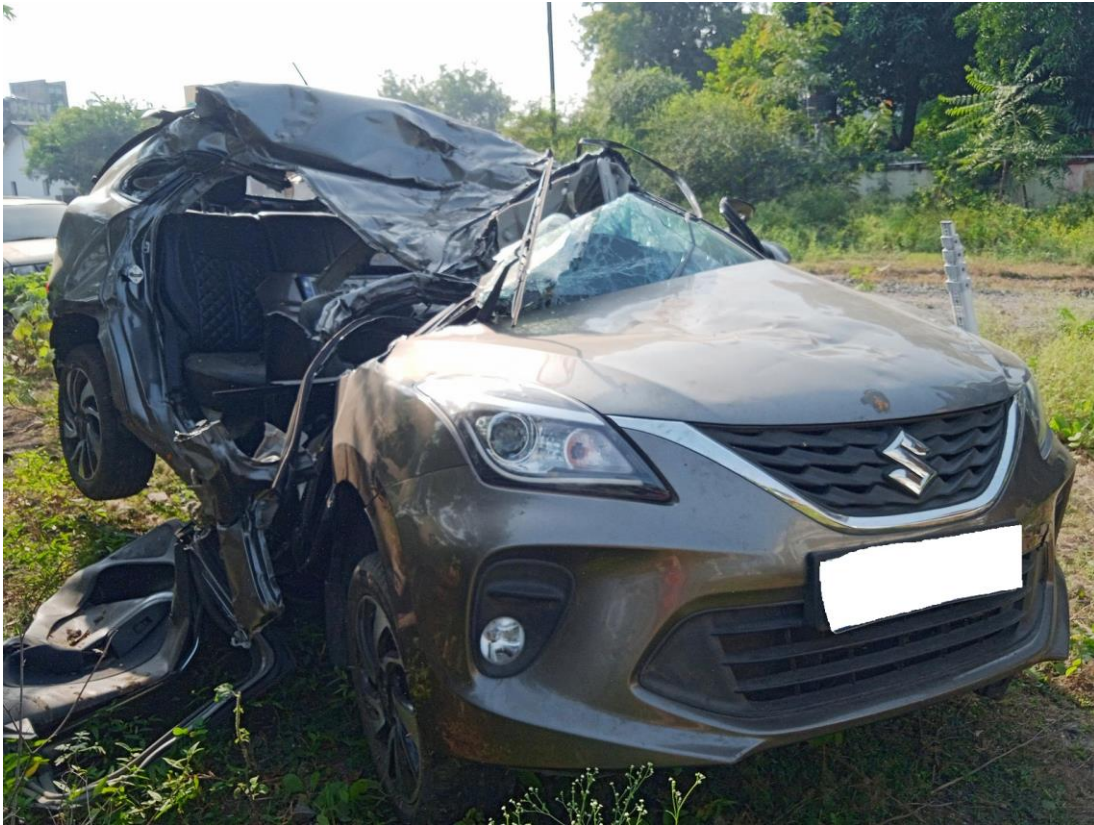
Car with 4 occupants was travelling on a 2-lane undivided state highway. Unit 1 was travelling straight on the left lane of the road and the vehicle went off the roadway and collided with a tree.

3 occupants including driver of the unit 1 were fatal on the spot & one occupant succumbed to death after 8 days of hospitalization.

Accident Time: 8:30 PM

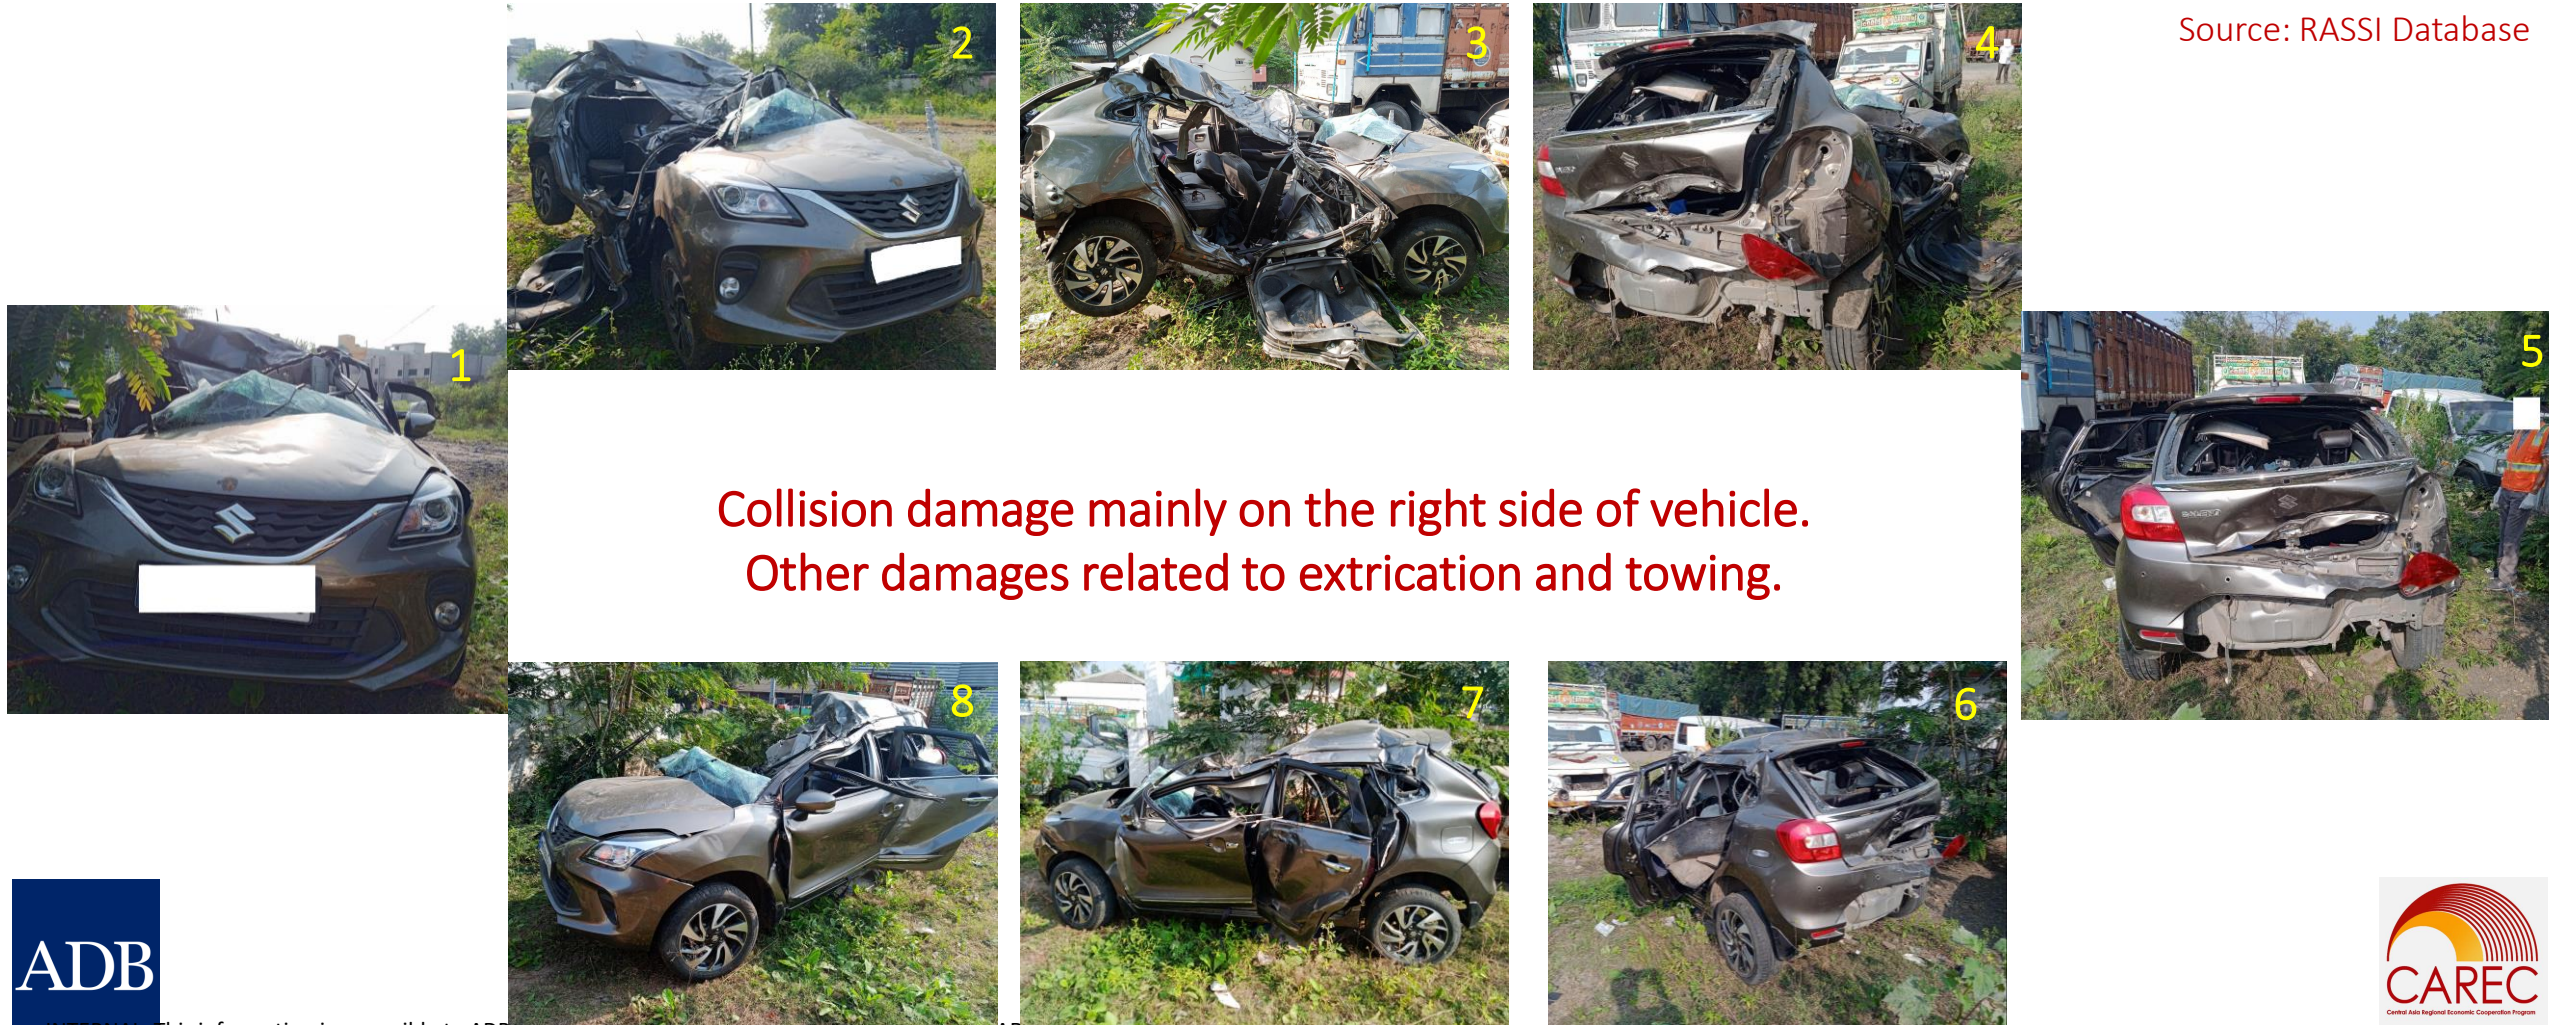
8-ANGLE PICTURES

Collision damage mainly on the right side of vehicle.
Other damages related to extrication and towing.

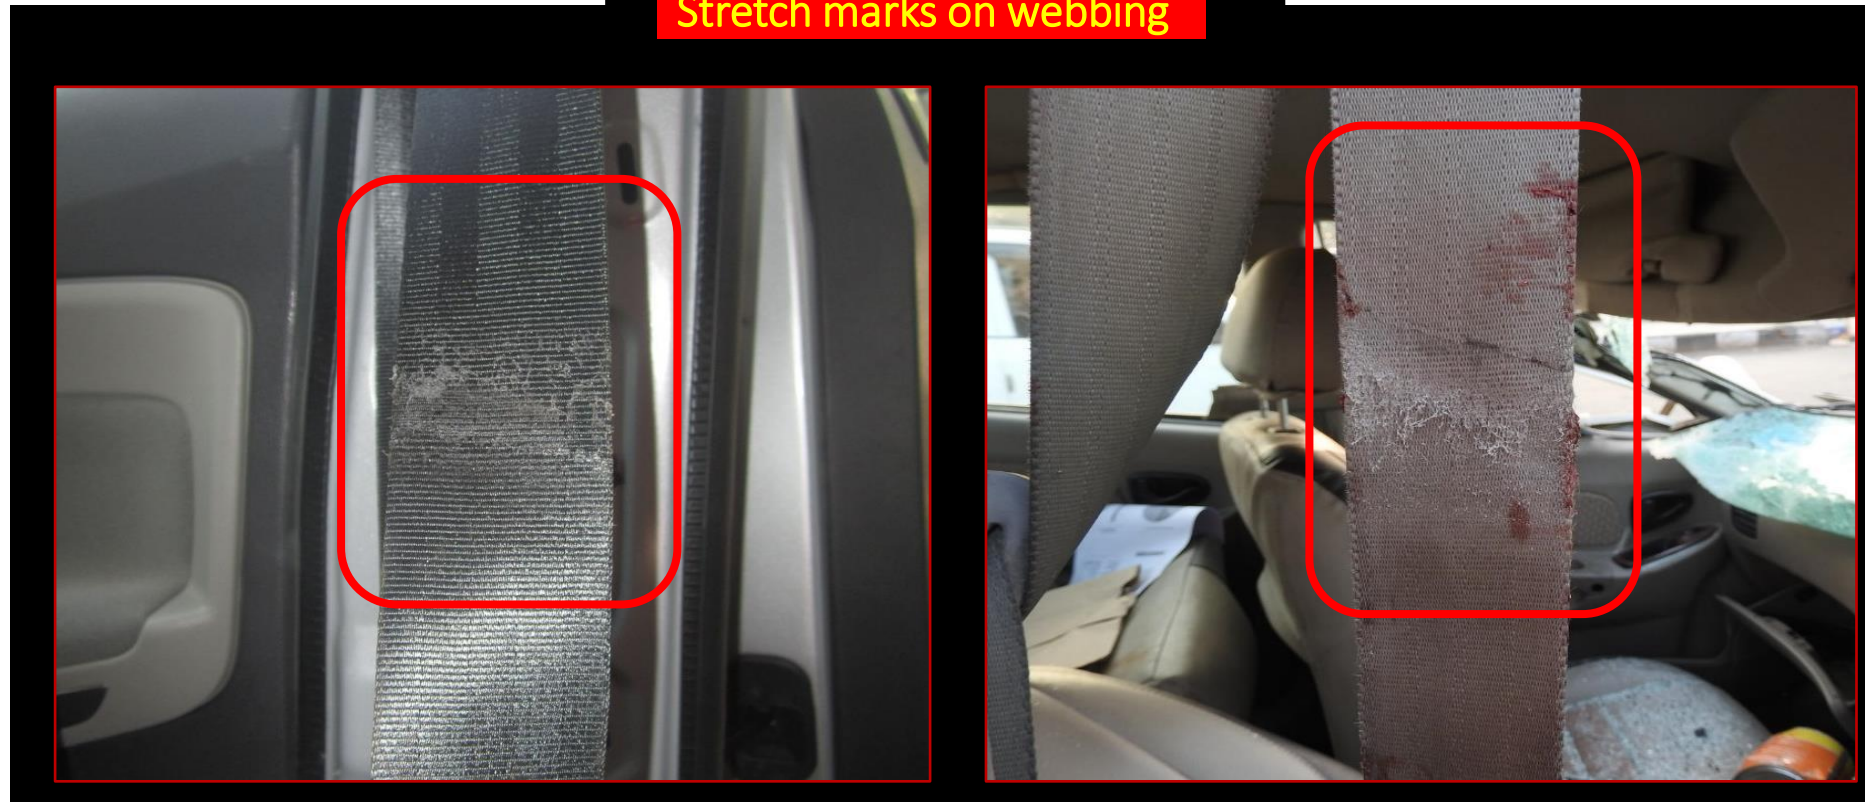
SEAT BELT INSPECTION

Stretch marks on webbing

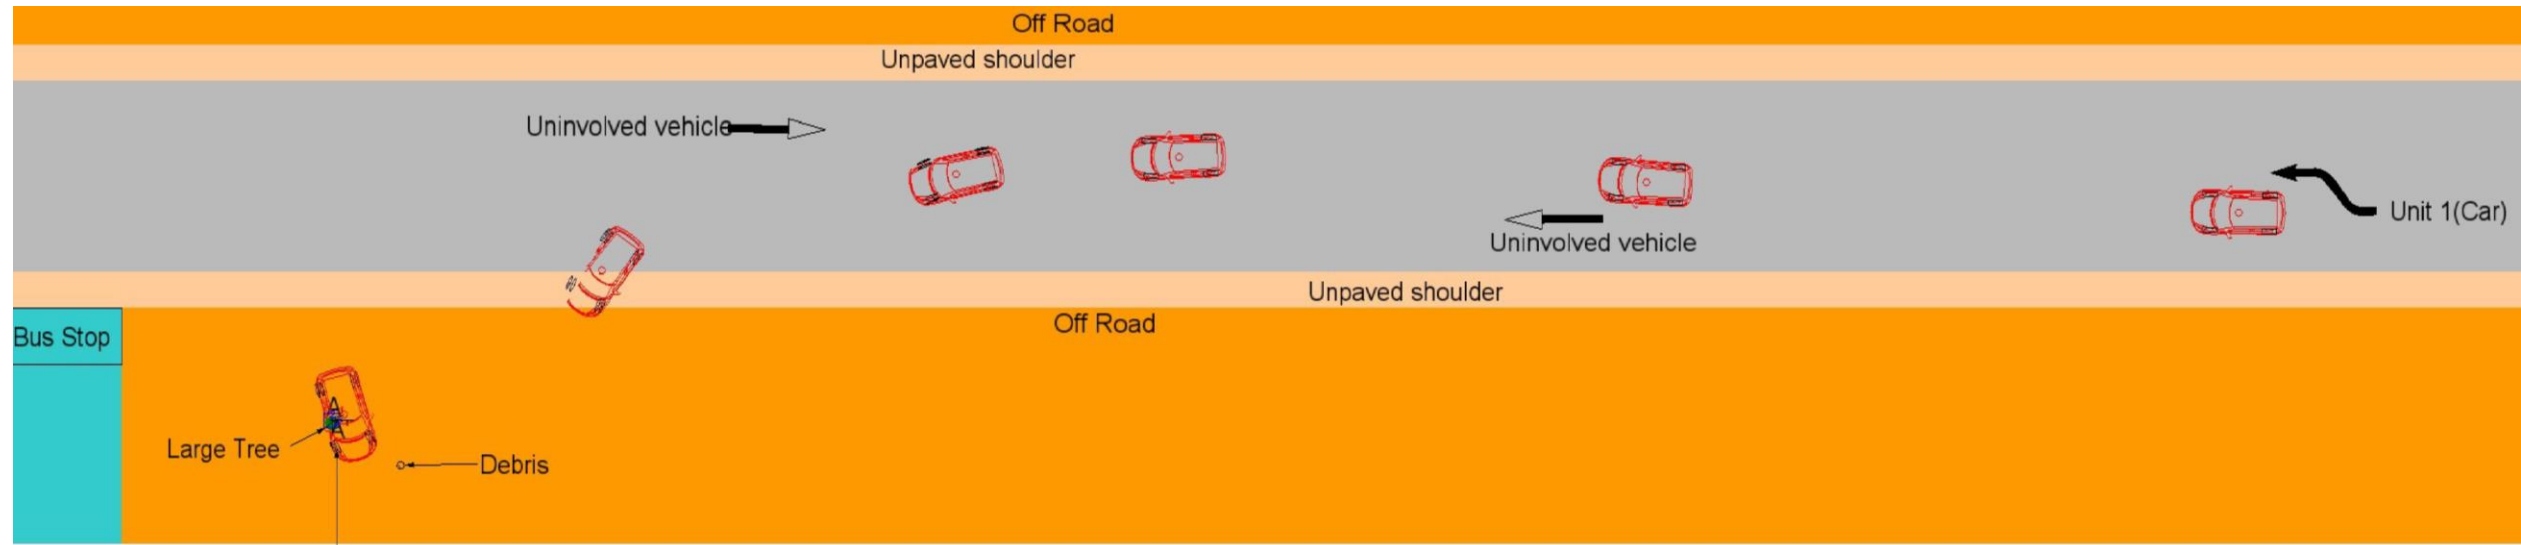
SCENE DIAGRAM

Large Tree
Debris

Point of impact & Final Rest position of Unit 1

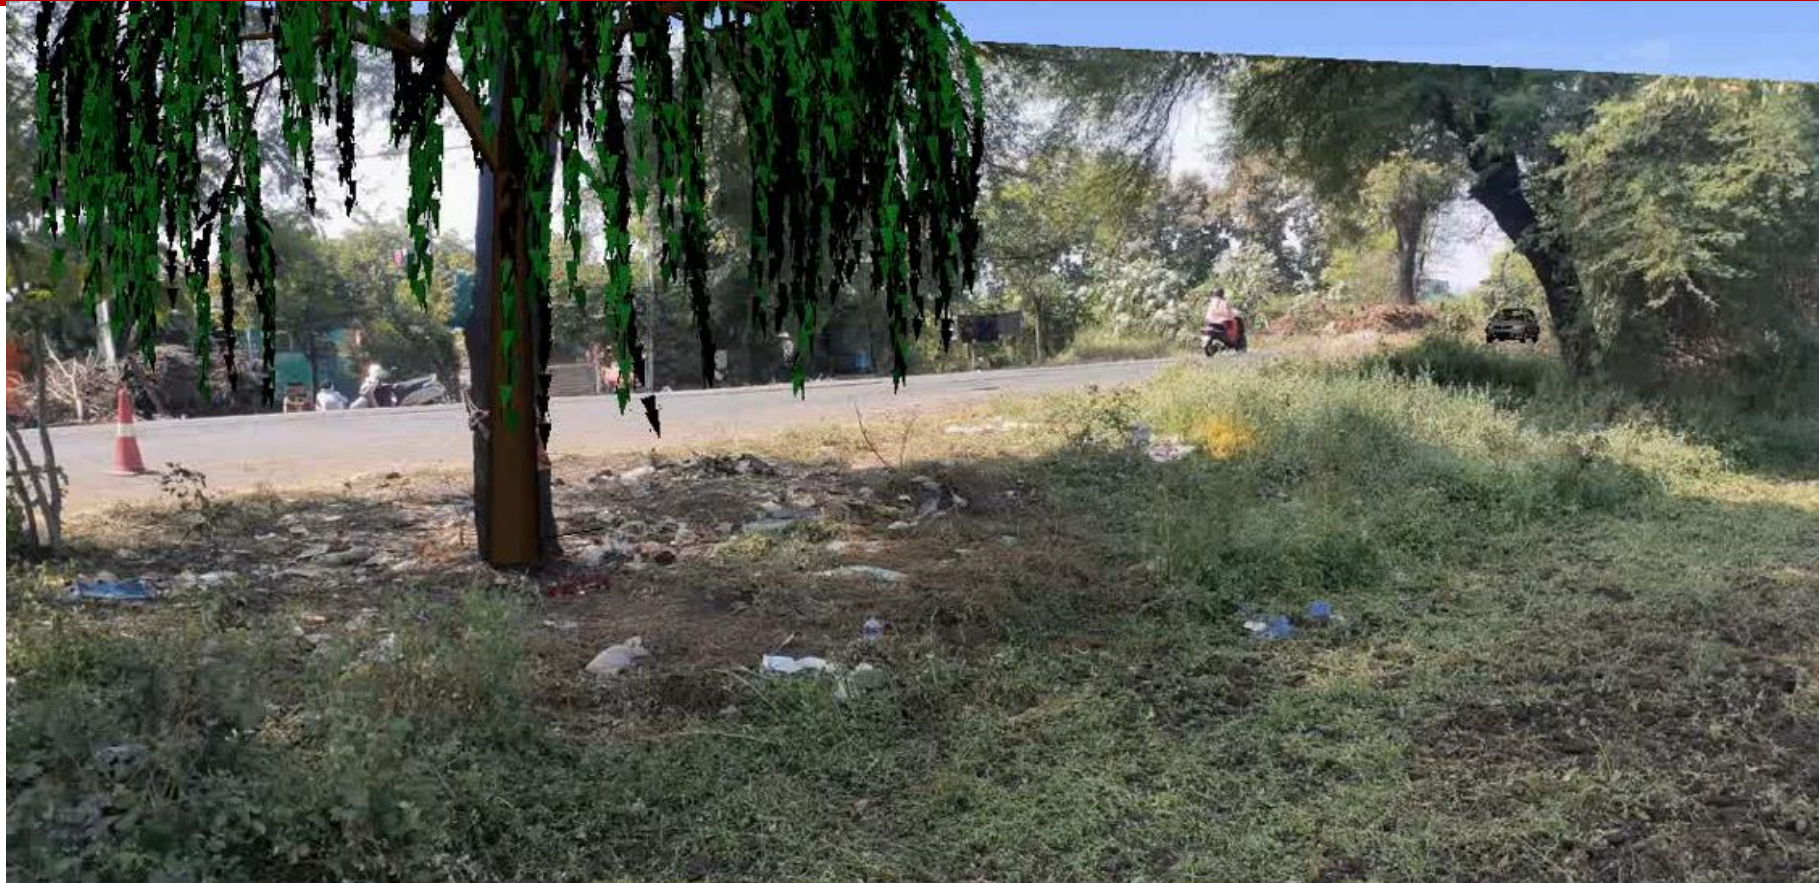
ACCIDENT RECONSTRUCTION

CAR SPEED 80 (± 10) KPH
