CAREC Road Safety Engineering Manuals

# I. Road Safety Audit

Detailed design stage audit of the proposed duplication of a national highway.

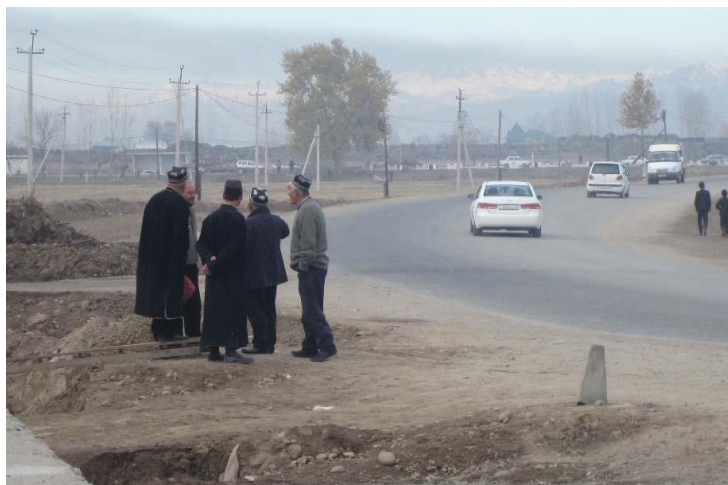
The existing single carriageway highway near km 21 showing typical road user groups

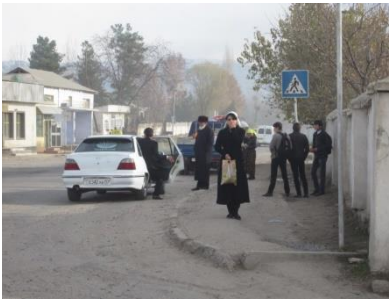
KM.	SAFETY CONCERN	RISK	PHOTO	RECOMMENDATION	CLIENT RESPONSE
<b>SAFETY CONCERNS WITH THE PROPOSED DUPLICATION OF THE NATIONAL HIGHWAY</b>					
From Km 5+400 to 6+300	This section of road passes through a village and it will be subjected to high speed traffic once the road is built. There will be a risk of high speed collisions between through traffic and pedestrians in this village. It warrants speed management to maintain speeds at or below 40km/h because of the high numbers of pedestrians in this village. The drawings do not show any "traffic calming" treatments proposed for here.	<b>VERY HIGH</b>

<ul style="list-style-type: none"> <li>- Install a "gateway" on both approaches to this village.</li> <li>- Install flat topped road humps at spacing's of approx. 150m through the village. Ensure that humps are located close to bus stops and the Police Station, that they are well signed, marked and lit.</li> <li>- Provide a physical median through the village (to serve as a refuge), but DO NOT install barrier or fencing on the median.</li> </ul>

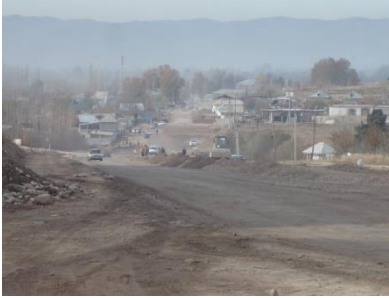
From Km 13+500 to Km 14+300	This village is located at the end of a long straight downhill section of road (from the capital) and a long straight flat section of road (from the south west). It is expected that speeds will be high through this village once the highway is duplicated. The highway takes a right-hand curve in this village and a major side road continues straight. The village warrants speed management to maintain speeds at or below 60km/h because of the many pedestrians in this village. The drawings are silent about this.	<b>VERY HIGH</b>

<ul style="list-style-type: none"> <li>- Install a "gateway" on the three approaches to this village.</li> <li>- Install flat topped road humps at spacing's of approx. 150m through the village. Ensure that humps are located close to bus stops, mosques and schools and that they are well signed, marked and lit.</li> <li>- Provide a raised concrete median 2m wide through the village to serve as a pedestrian refuge.</li> <li>- DO NOT install barrier or fencing on the median.</li> </ul>

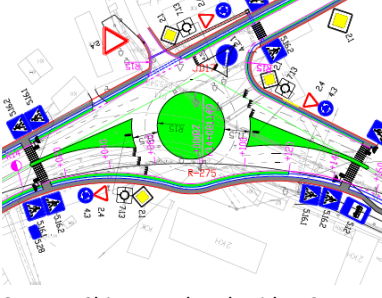
KM.	SAFETY CONCERN	RISK	PHOTO	RECOMMENDATION	CLIENT RESPONSE
<p><b>Km 14+080</b></p>	<p>The design for the roundabout proposed for this key intersection in this village has insufficient deflection from the west and from the south to cause drivers to slow sufficiently. This lack of adequate deflection will increase crash risk at the roundabout.</p>	<p><b>MED</b></p>

<p>Source: China Road and Bridge Corp.</p>	<ul style="list-style-type: none"> <li>- Review this design and attempt to improve deflection for these approaches.</li> <li>- If this is not possible, reconsider the use of a roundabout at this intersection. Seek alternative traffic control options instead.</li> </ul>	
<p><b>Km 15+710</b></p>	<p>At Km 15+710 a median opening and a T junction is proposed for access to the Village Access Road. The median opening will also serve as a U-turn opportunity. However, there are no sheltered left turn lanes proposed in the median for either direction. There will be a high risk of rear end collisions at this location as vehicles slow down to turn from the “fast” lane.</p>	<p><b>MED</b></p>

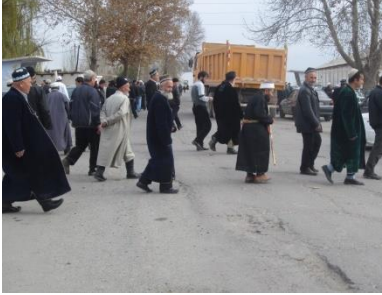
<p><b>Km 23+150</b></p>	<p>There is a large mosque on the southern side of the road. During Friday prayers hundreds of men attend this mosque, parking their vehicles on both sides of the road. The drawings show no parking and no pedestrian facility is to be provided, although both are needed. It will be more dangerous for pedestrians walking across the new duplicated highway due to increased speeds on it. The highway needs to be kept open for through traffic.</p>	<p><b>VERY HIGH</b></p>

<p>Photo credit: Phillip Jordan</p>	<ul style="list-style-type: none"> <li>- Consider providing off road parking close to the mosque for use by those attending the mosque.</li> <li>- If this is not possible, seal the shoulders of the highway (2m wide) for at least 250m either side of the side road leading to the mosque to encourage orderly parking.</li> <li>- Construct an all-weather footpath between the mosque and suitable breaks in the W-beam barrier on the southern side of the highway to permit pedestrian access to parked vehicles.</li> </ul>
