ROAD TRAFFIC ACCIDENT DATA COLLECTION AND ANALYSIS WORKSHOP COUNTRY: MONGOLIA

TA-6763 REG: Accelerating Innovation in Transport

CRASH DATA ANALYSIS

CASE STUDY 1: CAR COLLISION WITH TREE

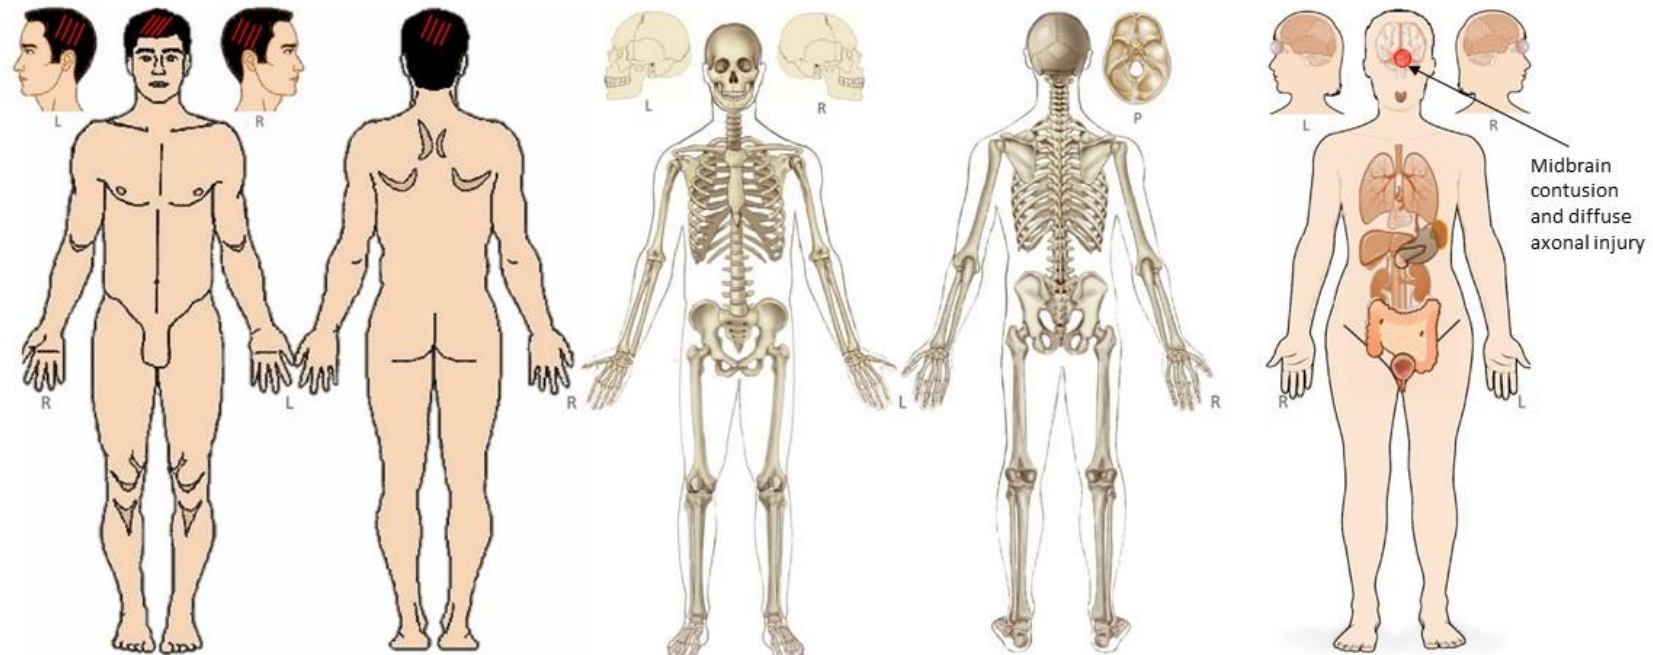
CO-PASSENGER INJURY SKETCH

CASE NUMBER	UNIT NUMBER	OCCUPANT NUMBER	OCCUPANT GENDER	OCCUPANT AGE	HISP	MAIS
91-2020-015-0001	1	2	Male	31	Fatal	5

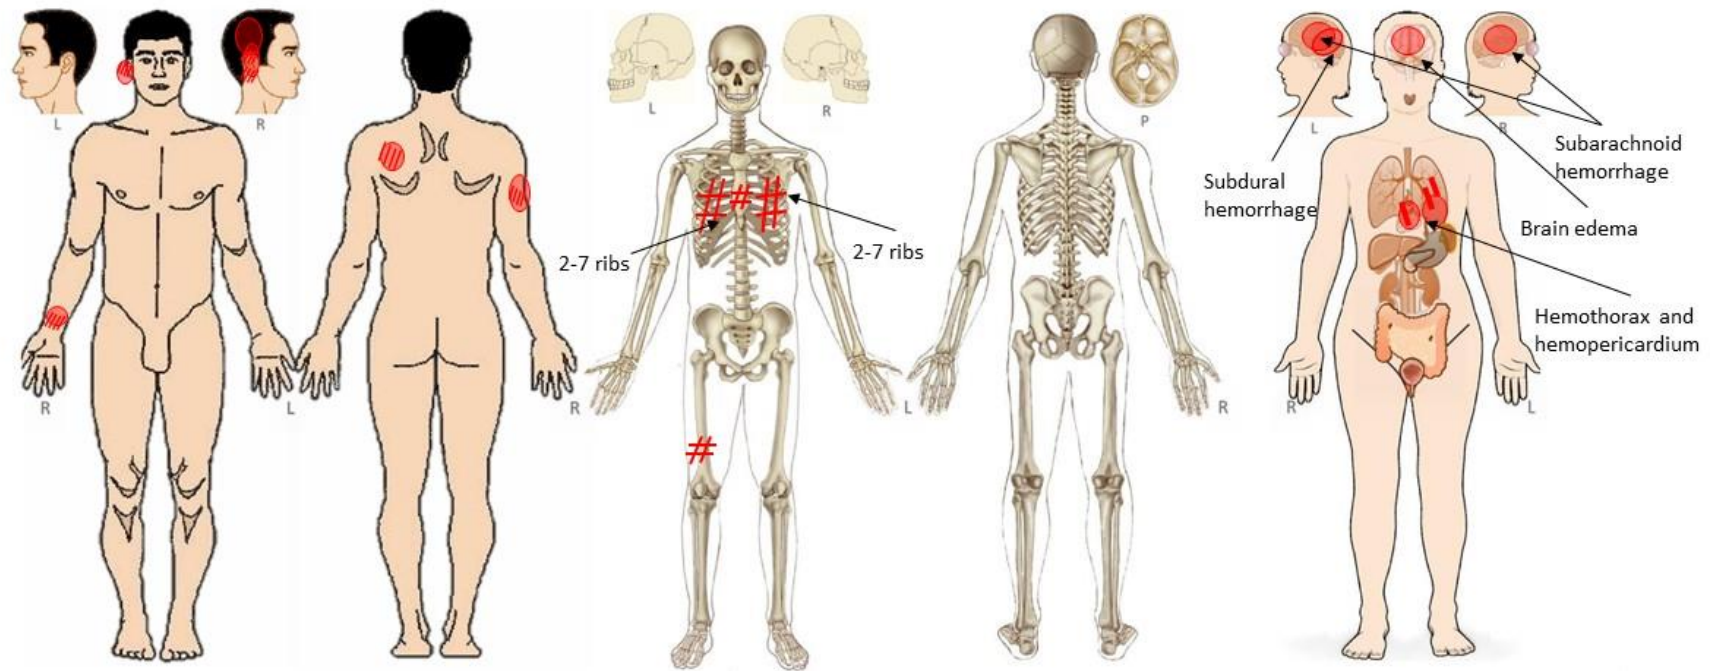
LEFT REAR PASSENGER INJURY SKETCH

CASE NUMBER	UNIT NUMBER	OCCUPANT NUMBER	OCCUPANT GENDER	OCCUPANT AGE	HISP	MAIS
91-2020-015-0001	1	4	Male	33	Fatal	4

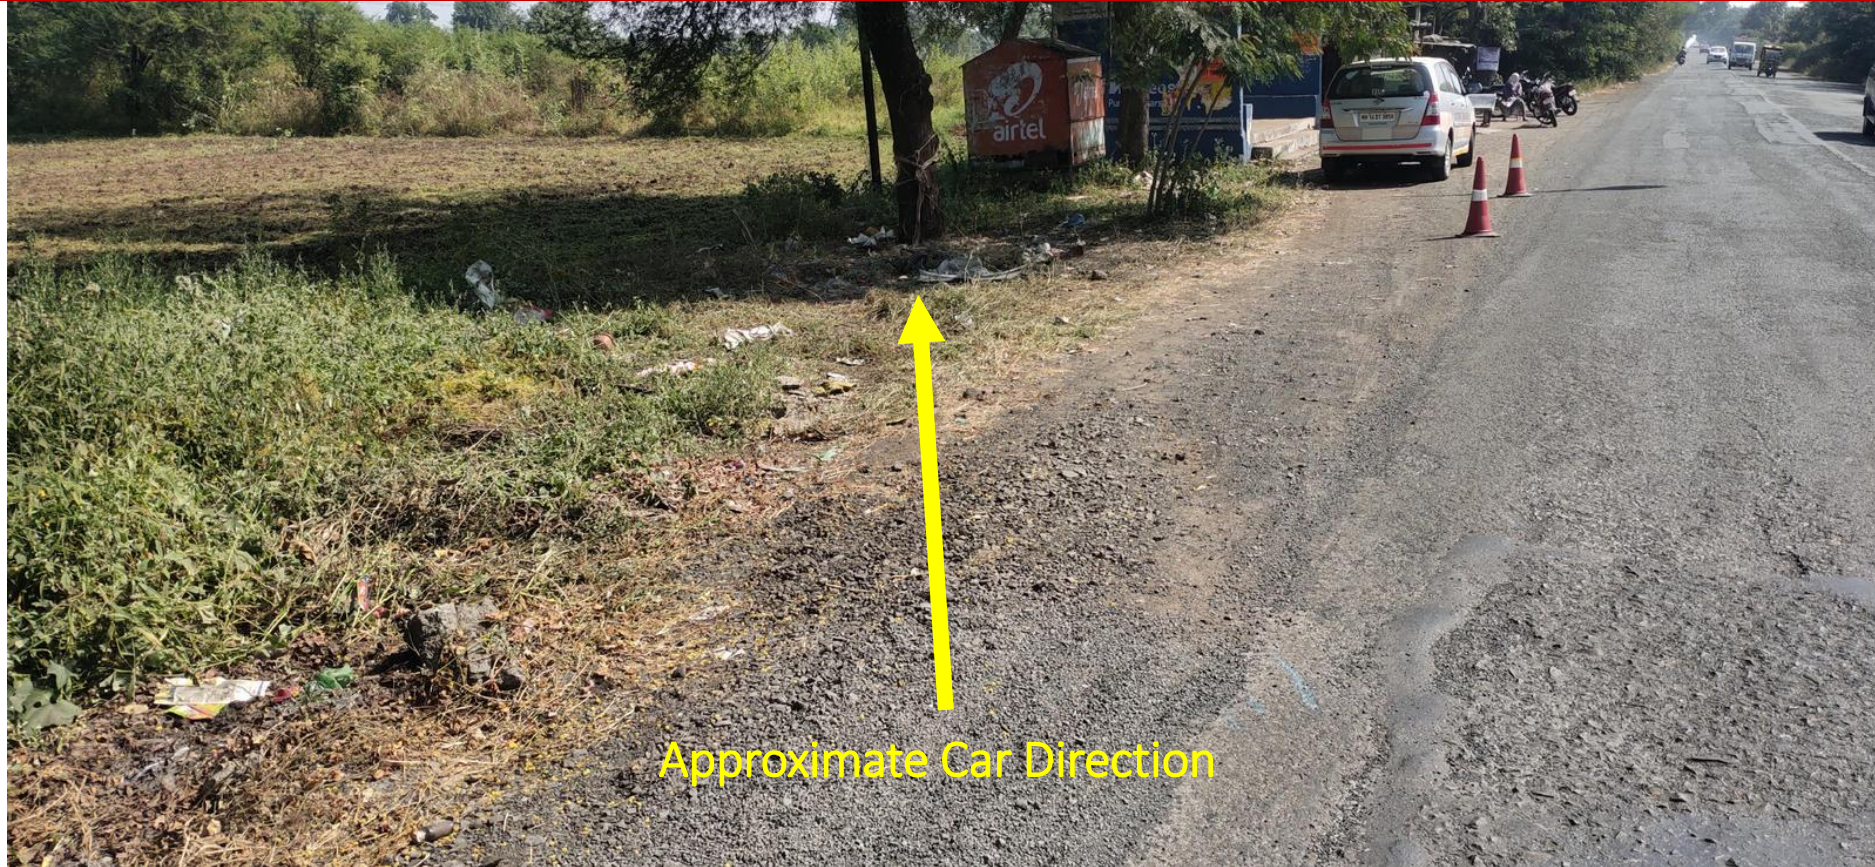
SCENE EXAMINATION

- Undivided 2-lane highway
- Poor road surface
- No road markings
- No speed limit signage
- Overtaking on oncoming lane
- Road side trees
- Road side shops/parking
- Road side bus stops
